Failure Analysis Control Board Project Early Failures Detected

/ Approach: Temperature Humidity Bias Test Setup

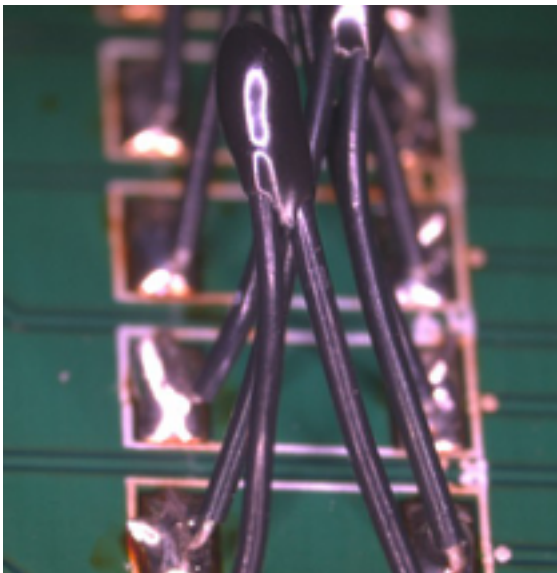
Thermistor prior to decapsulation

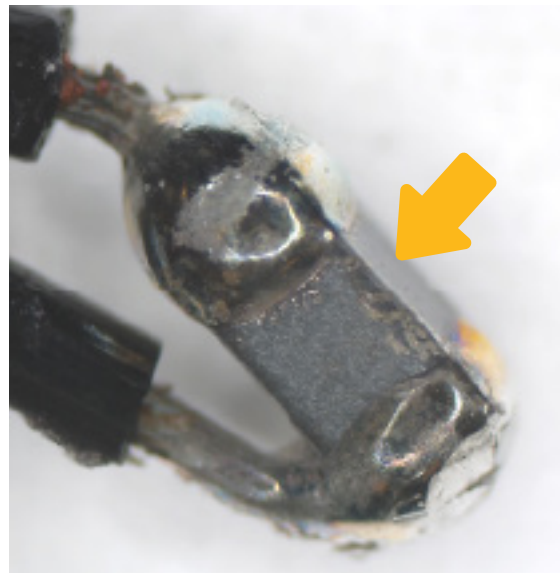
The thermistors resulting in failure were decapsulated through an iterative process of using an epoxy-specific solvent on a hot plate. Our engineers immediately noticed signs of an unknown material between the terminations while looking at the samples under the optical microscope.

Thermistor post-decapsulation under optical microscope

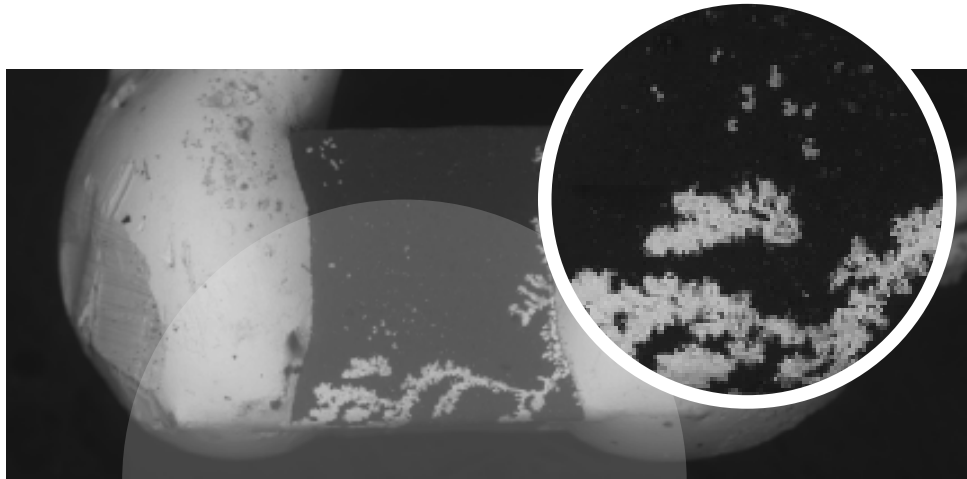
In the scanning electron microscope (SEM), the images collected show signs of migration — dendritic growth shorting the two terminations.

Ansys RES' primary recommendation was to switch to the second thermistor supplier. As an alternative, we recommended verifying whether baking the current thermistors for 24 hours at 105 C would improve THB performance (by removing suspected initial moisture). However, a follow-on project showed that even baking did not eliminate failures.

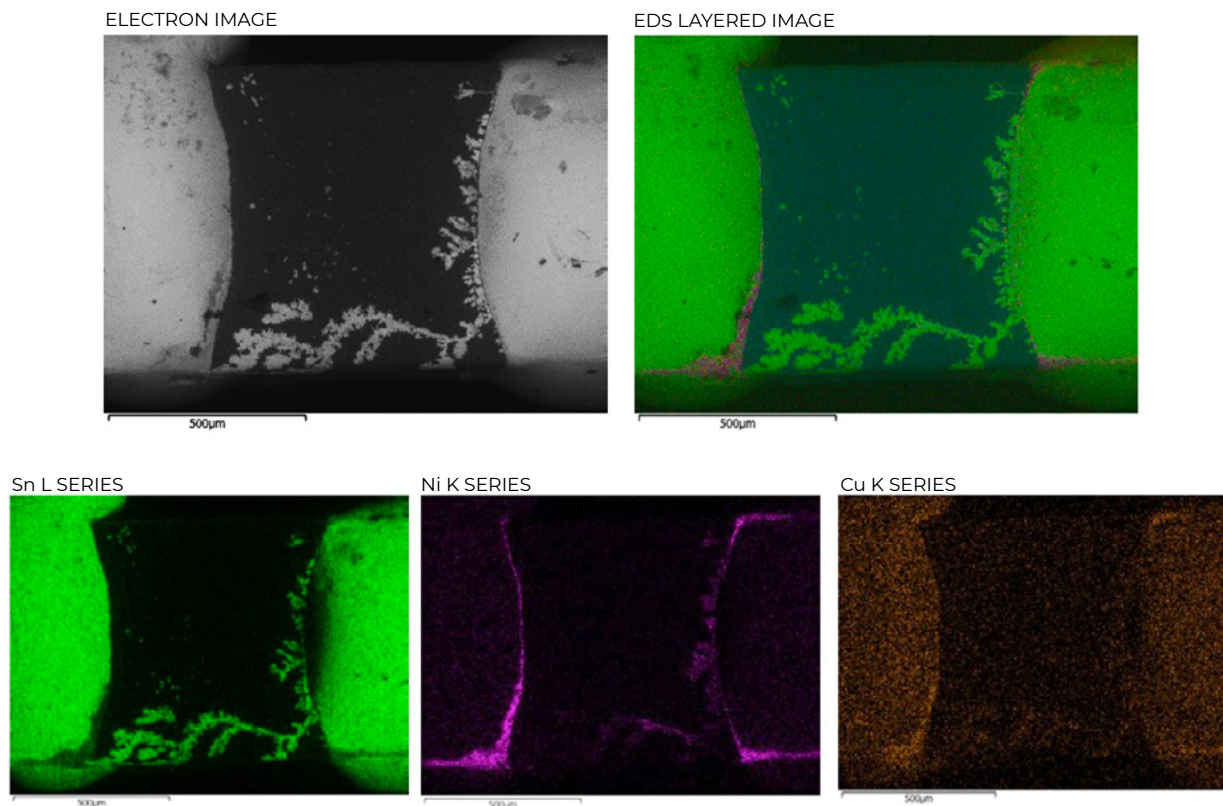
Furthermore, energy dispersive X-ray spectroscopy (EDS) analysis helped confirm the presence of the dendritic growth that was seen in the SEM images. Areas of high nickel and copper corresponded with regions of terminals that had depleted tin. This combination of SEM and EDS analysis highlighted evidence of migration of tin, which lead to shorting between the two terminals of the thermistor.

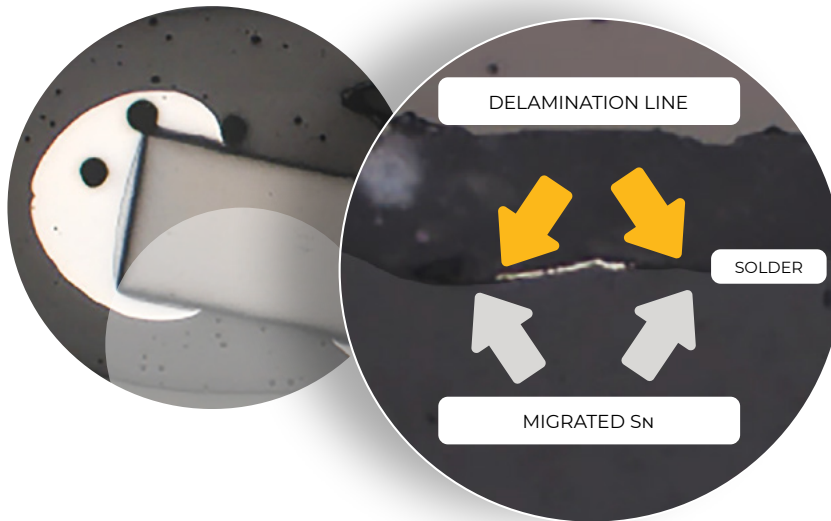
Cross-sectioning revealed scattered voiding in the epoxy encapsulant, including a void close to the interface of the epoxy and thermistor body. Voiding along the epoxy/thermistor interface makes the device susceptible to delamination and moisture ingress, creating the environment needed for dendritic growth under bias.

The images below reveal an apparent demarcated line on the bottom side of the component, confirming signs of tin migration.

Both decapsulation and cross-sectioning showed signs of electrochemical migration of tin in multiple components that failed temperature humidity bias testing. Additionally, cross-sections showed signs of a thin delamination line at the epoxy/thermistor interface caused by tin migration, further indicating the presence of moisture ingress and delamination to allow dendritic growth.
